1775H - CR 119,651

Advanced Manufacturing Development of a Composite Empennage Component for L-1011 Aircraft

QUARTERLY TECHNICAL REPORT - NO. 13

This report is for the period 1 January 1979 through 31 March 1979

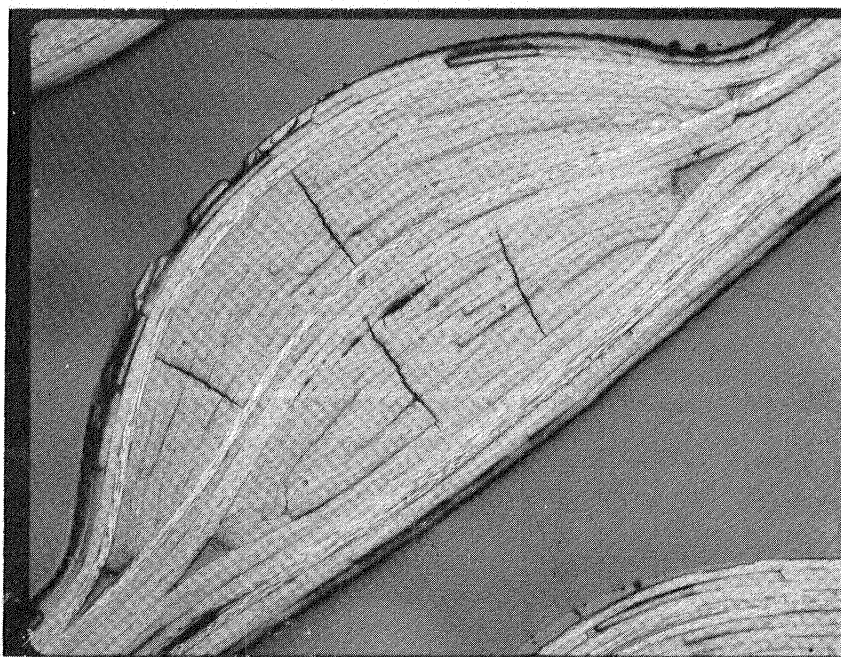
Figure 3-6. Bead Molded in Tool Cavity

Figure 3-6 and 3-7 show that cracking occurred in both beads, and the beads flattened and spread.

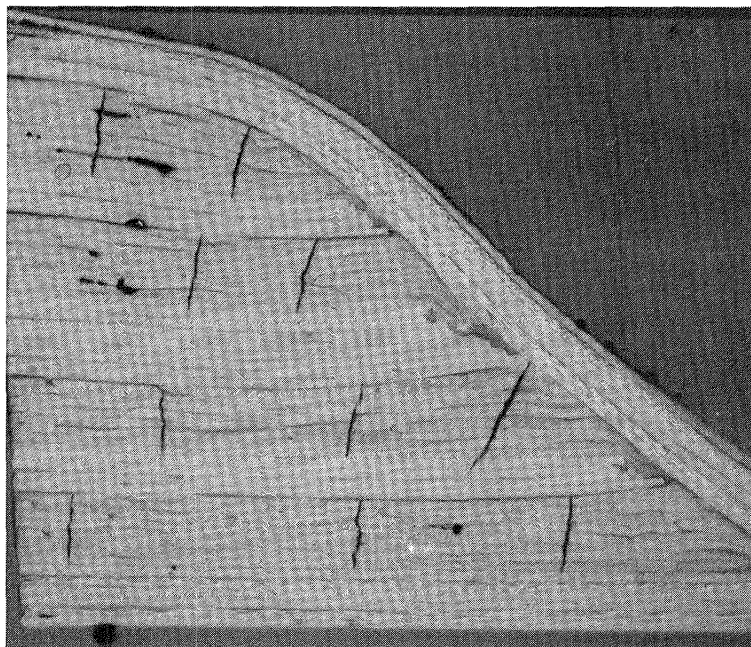
Figure 3-16. Microcracks Through 0° Plies of Solid Web Rib Bead Stiffener.

In the baseline solid web rib design, the transverse stiffeners were located in a slotted cavity in the male tool. Fabrication of these "T" sections was difficult and time consuming. They were replaced by bead stiffeners laid on top of the laminate and capped by a 4-ply layer of prepreg. Following a sequence of events similar to the truss rib caps a new bead, designed to reduce microcracking, was developed. This design utilized $\pm 45^\circ$ plies as well as 0° plies. However, microphotos (Figure 3-16) revealed that microcracks traveled through the 0° plies and were stopped by the $\pm 45^\circ$ plies.

As a result, a new approach to stiffening the solid web rib was taken. Basically the design is a sandwich: six plies graphite tape, syntactic resin core, six plies graphite tape. Figure 3-17 illustrates the basic construction. The syntactic resin core and adjacent graphite prepoly are cut to size using templates. The part is assembled and "Air Dam" strips are pressed around the exposed edges of the laminate. A molded silicone bag, acting as a caul, is placed over the breather and bleeder system. Finally, a nylon vacuum bag is placed over the entire assembly.

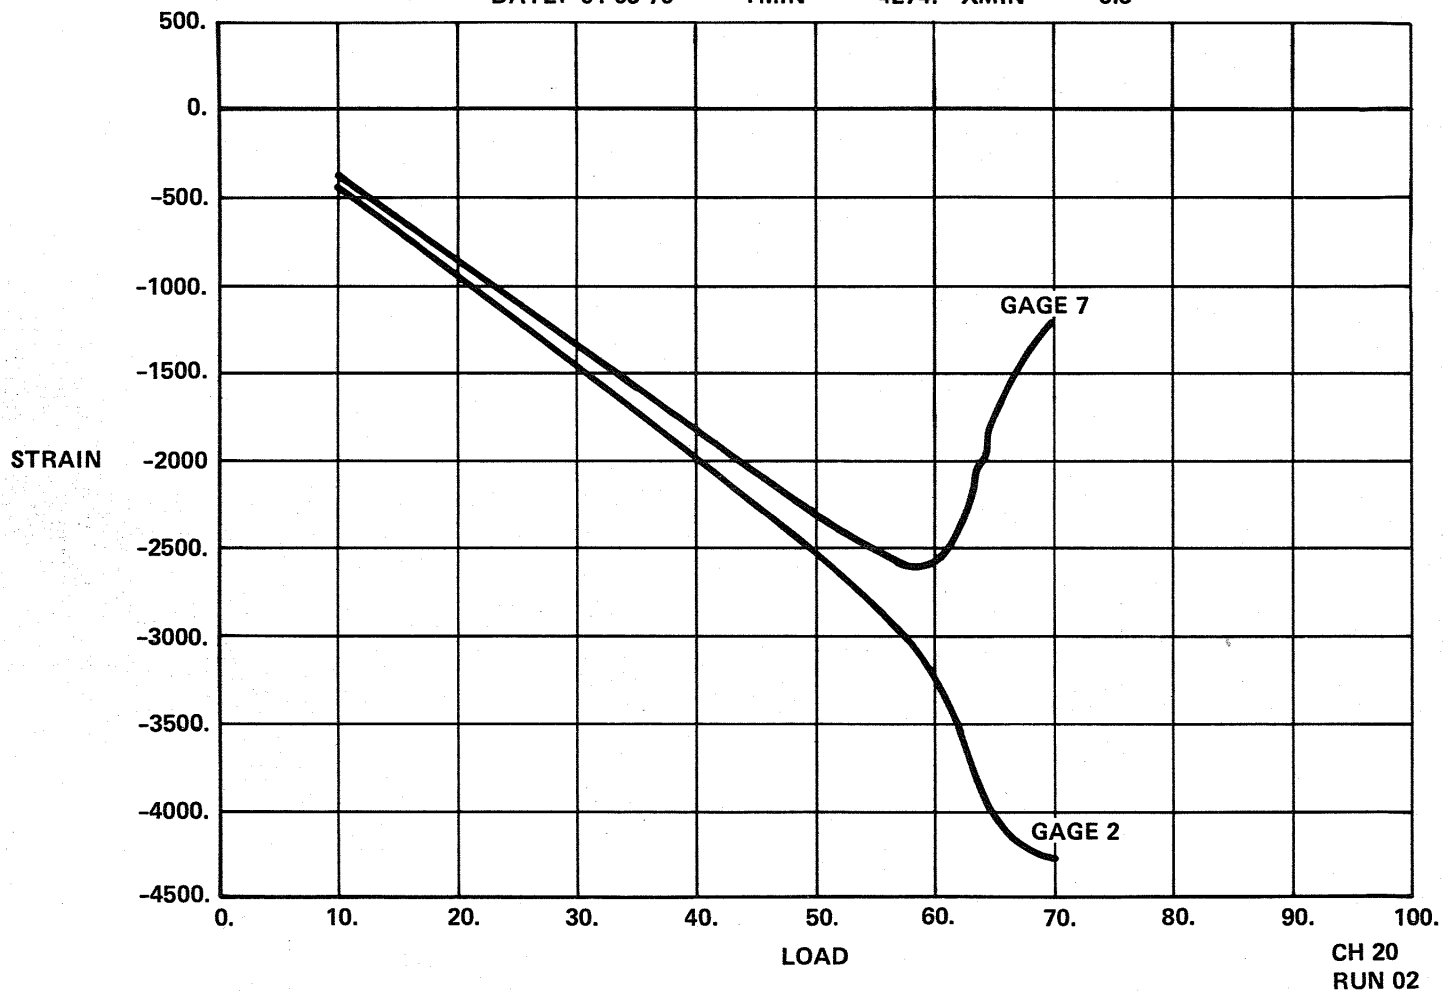
Figure 4-6. Strain Gages 2 and 7 - Failure Condition

The second test objective was to run the panel continuously to failure with the data being continuously recorded during the test. Failure of the panel occurred at 70,000 lbs, 120% of ultimate load. Initial buckling was indicated in the back-to-back skin gages at about 54,000 lbs compression. Figures 4-6 and 4-7 show the buckling of the skin panels between the hats. The predicted failure loading was 80,000 lbs and predicted initial buckling was 48,000 lbs.

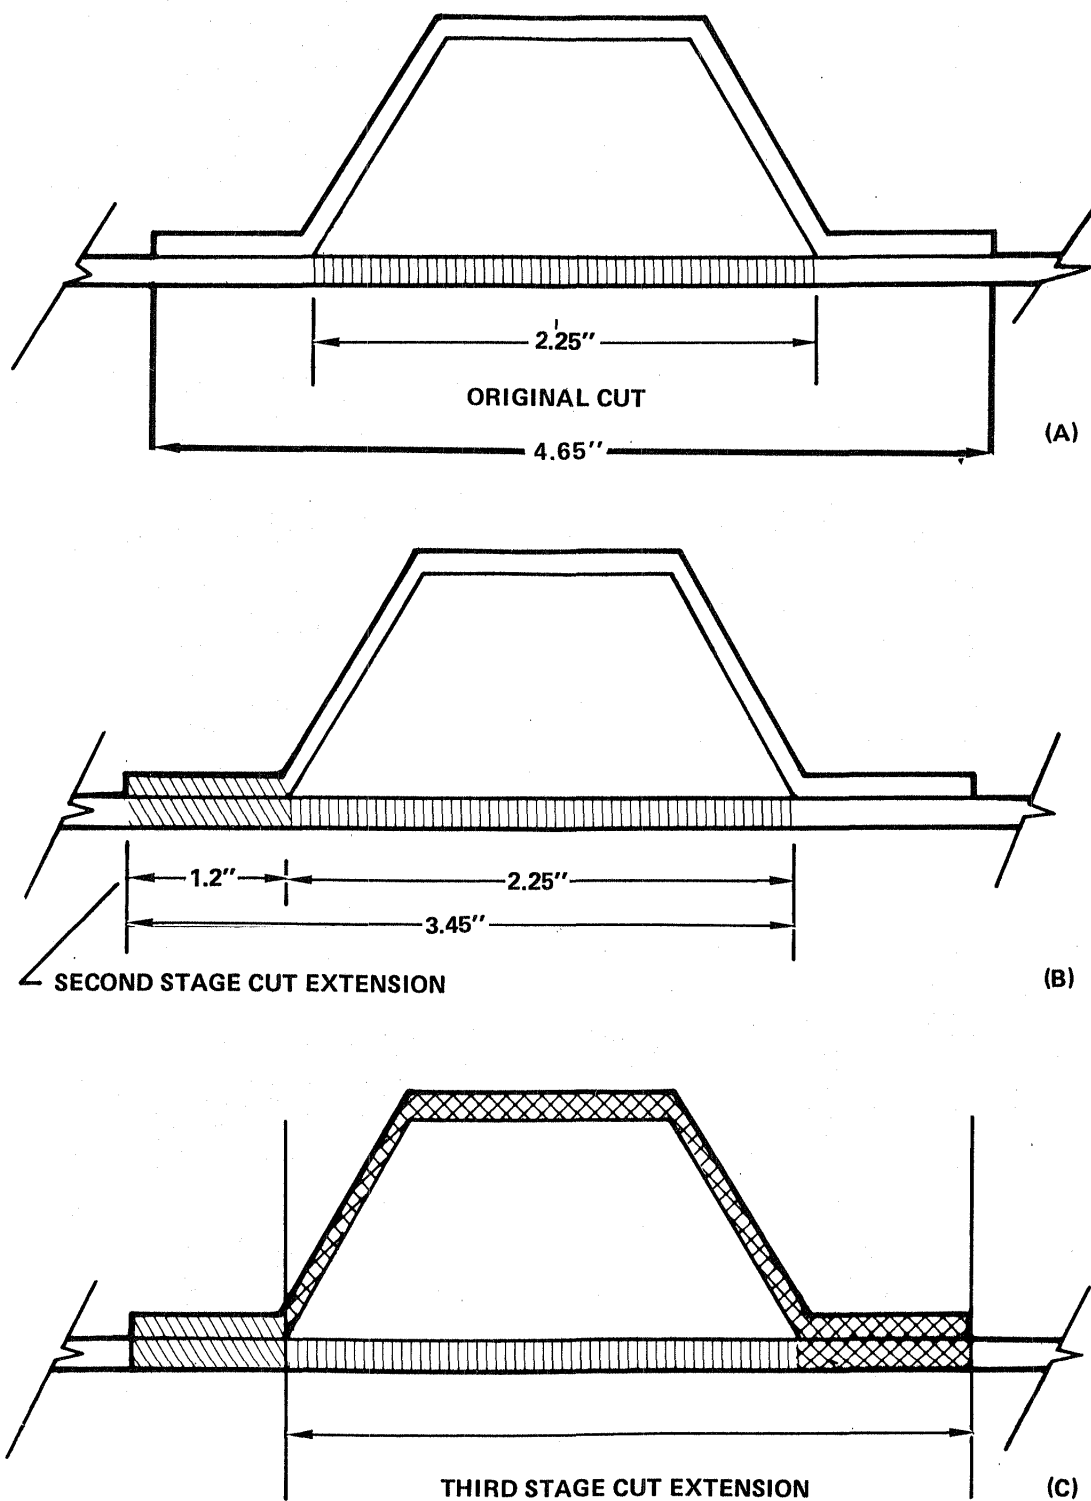
Figure 4-11. Panel Saw Cut Stages

After the 1/2 lifetime (18,000 flights) the limit load cycles were applied. A loud "pop" was audible and visual examination showed that cracks had developed in two areas: (1) at the end of the saw cut in the skin, 3 cracks 1/8 to 3/16 inches long; and (2) in the hat side wall at the region of the saw cut intersection. The skin cracks were examined ultrasonically and were found to be surface delaminations only. The hat cracks and damage were confined to the side wall of the hat in an area about 3/8 inches in diameter. The flight-by-flight spectrum was again initiated for another 1/4 lifetime. During the first 1800 flights of this sequence, the crack on the hat sidewall grew to the crown of the hat and stopped. No further growth was noted for the duration of this run other than some minor surface layer fiber delaminations. Also noted were some minor amounts of surface fiber lifting at countersunk fasteners between Bays 2 and 3. The spectrum testing was continued for an additional 1/4 lifetime (full lifetime total) with no change in growth noted. Up to this time 2 cycles of limit load had been applied to the specimen.

After completion of the full lifetime (36,000 flights), the saw cut was extended completely through the hat including the crown and both flanges as shown in Figure 4-11c. The spectrum loading was then continued for an additional 1/2 lifetime. Only minor crack growths were noted.

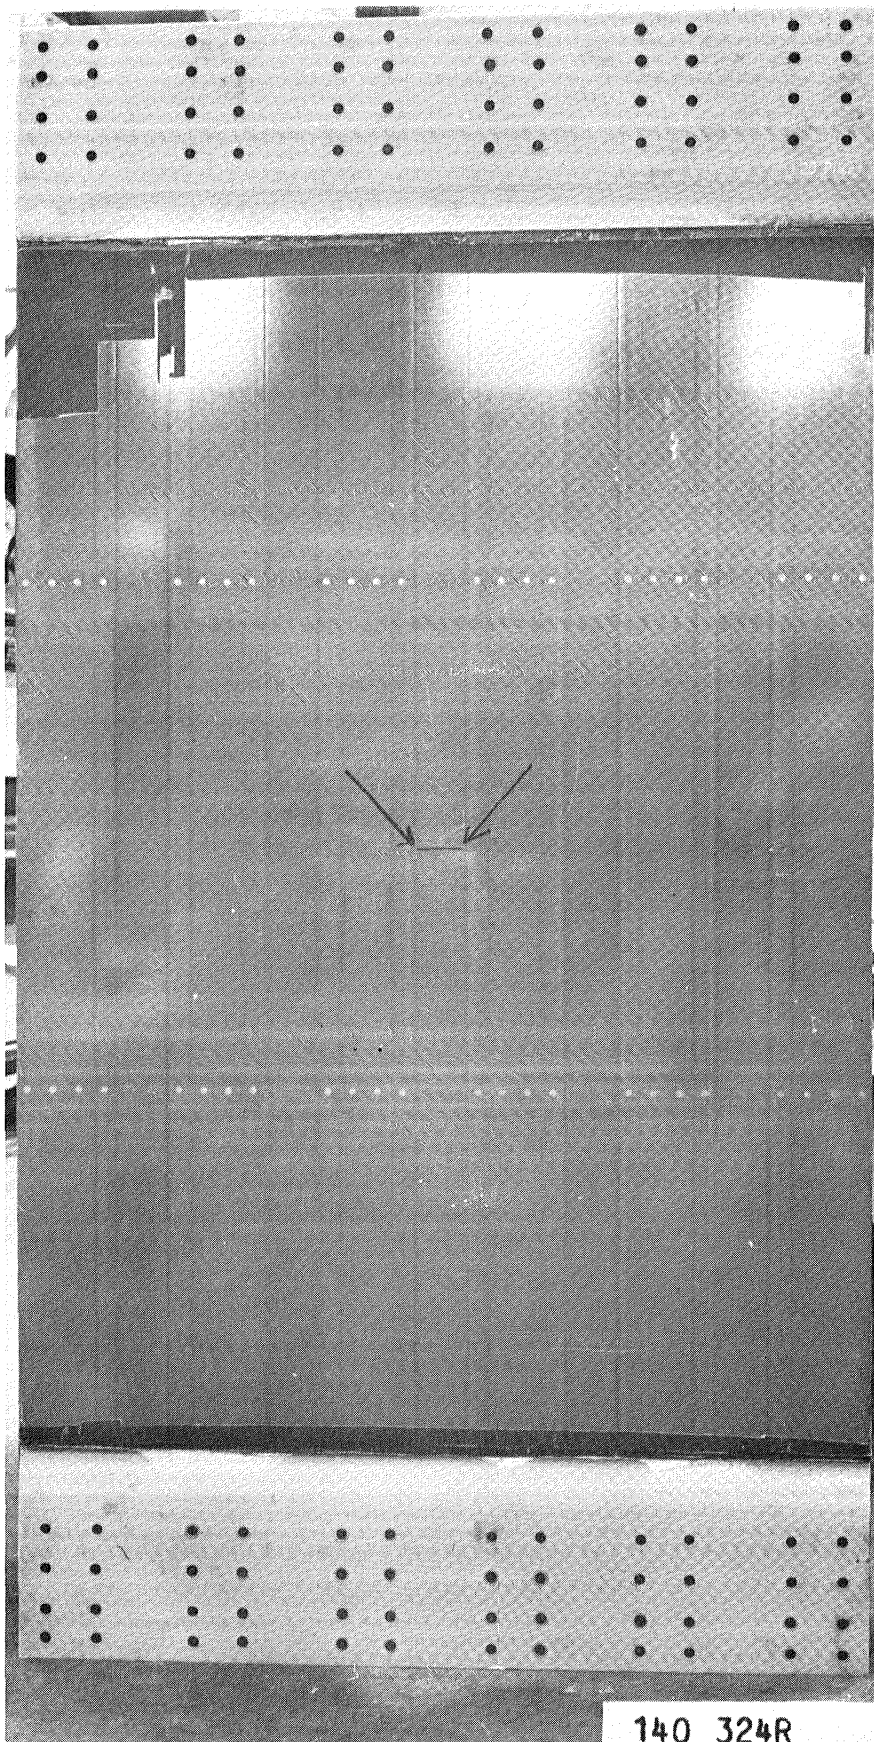
Figure 4-12. Saw Cut Under Center Hat

The panel was a five hat stiffened section approximately 41 in. wide and 80 in. long. The test section had two simulated rib stations attached and had end attachments for test machine attachment as shown in Figure 4-10. A cut was placed on the face sheet, 2.25 inches long, directly under the middle hat as shown in Figure 4-11a. A photograph of the saw cut panel is shown in Figure 4-12. The panel was instrumented with two axial strain gages on the
